SERVICE BULLETIN

Model: Elise '04 M.Y.

Number:
2004/27

TITLE: Rectification of water ingress via sunvisor brackets.

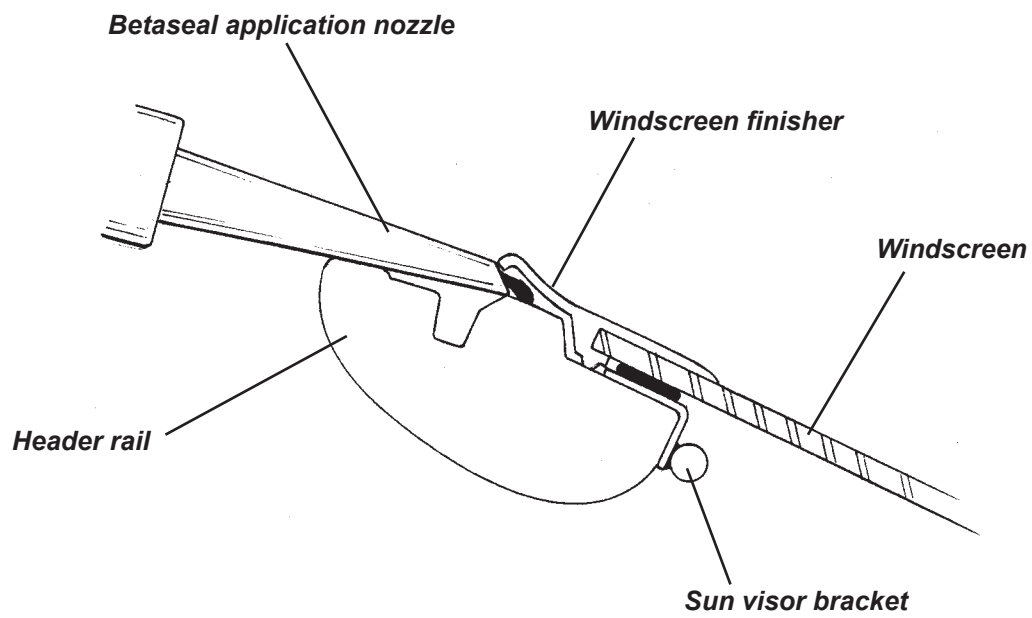
SB85

REASON: The sun visors, introduced as an option on '04 M.Y. Elise, are mounted on brackets bonded onto the windscreen frame and overlaid by the windscreen adhesive. It has been found that deficient priming of the bracket top surface can result in incomplete bonding between screen and bracket and possible water ingress under certain conditions.

1. Remove the soft or hard top roof.
2. Using the nozzle of the sealant cartridge, ease up the edge of the windscreen moulded surround finisher, and extrude a continuous bead of sealant/adhesive between the finisher and header rail from around each top corner as shown in the diagram.
3. Lightly press down the finisher to ensure suitable spread of sealant and correct surface profile.
4. Refit soft top or hard top roof and water test.

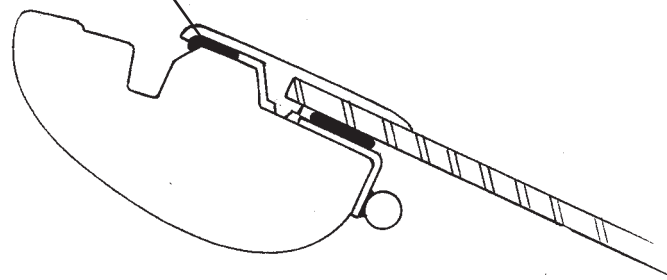
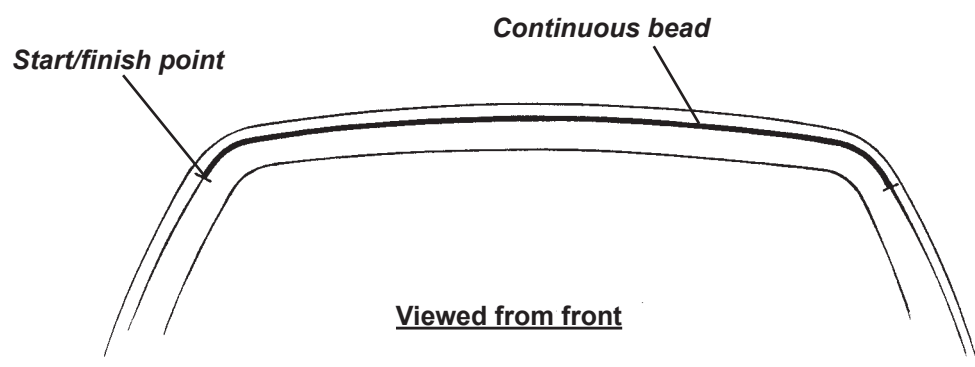
SB86

Finished condition
