SERVICE BULLETIN

Model: Accusump models

Number:
2008/10

TITLE: Precautions regarding fitment of Accusump one-way valve.

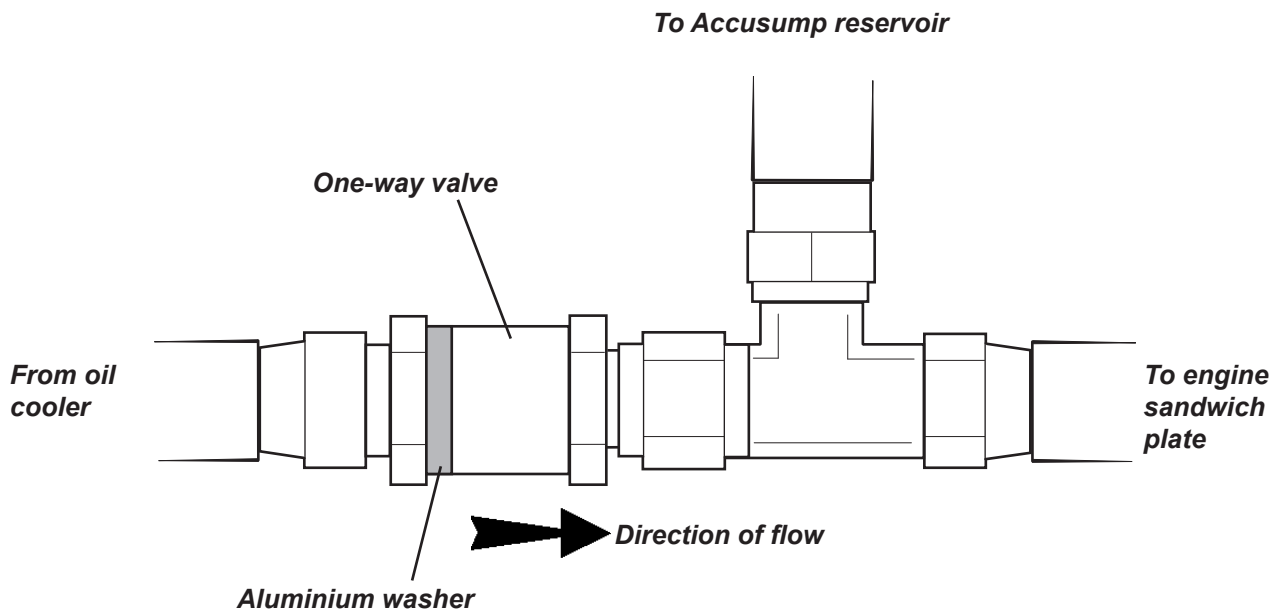
REASON: On any Elise/Exige fitted with the motorsport Accusump oil reservoir, incorrect location or orientation of the one-way oil flow valve can result in complete failure of the engine lubrication system and consequent engine seizure.

Note that there is no external indication of flow direction on the valve body, so that reference must be made to the assembly of the unit and the location of the aluminium sealing washer. For throughflow, the washer indicates the entry end of the valve, and the non-washer end the exit. Oil flow is blocked in the reverse direction.

The valve should be fitted between the reservoir line 'T'-piece and the return hose from the oil cooler (routed down the LH sill), with the flow direction towards the 'T'-piece. This ensures that when the reservoir discharges oil to prime the system prior to cranking, oil is directed into the engine and not the cooler. Inversion of the valve would block the engine lubrication circuit.

Fitment of the valve between the 'T'-piece and engine sandwich plate would result either in complete blockage of the oil system, or ineffectiveness of the Accusump dependent on valve orientation.

ACTION: If any Accusump system is being fitted, serviced or disturbed, it is vital to ensure that the one-way oil flow valve is correctly configured.
