SERVICE BULLETIN

Model: Elise/Exige

Number:
2009/02
USA

TITLE: Torque check of rear hub securing bolts on selected vehicles.

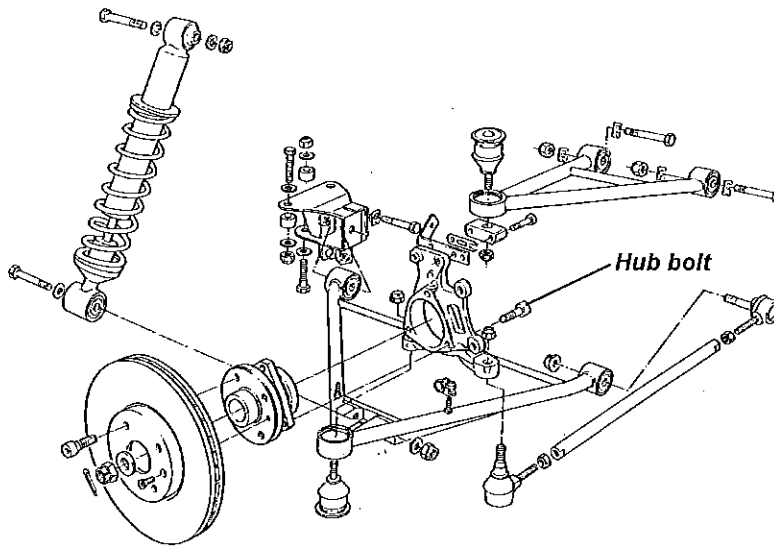
Note: The three hex. head bolts securing the hub bearing unit to the hub carrier are treated with Permabond A130 compound, and torque tightened to 90 Nm. In order to avoid breaking the adhesive bond, and the subsequent need for bolt removal, cleaning and adhesive re-application, the check procedure uses a lower torque setting in conjunction with witness marks.

1. Remove both rear roadwheels.
2. From the inboard side of the hub carrier, match mark the position of the three bolts securing the hub bearing unit to the hub carrier, by scribing a line across the head and onto the carrier.

3. Using a short torque wrench with 19mm crowsfoot adaptor ring, apply a 70 Nm tightening torque to each of the bolts in turn. If a suitable torque wrench or adaptor is not available, use a well fitting thin wall 19mm ring spanner, and apply full effort.

4. Examine the match marks to determine if any bolt movement has occurred;
 - if no; mark the bolt heads with white paint, and re-assemble (wheel bolt torque = 105 Nm).

- a) Remove the hub carrier from the car (see Service Notes sub-section DH.3).
 - b) Thoroughly de-grease and clean the female threads in the hub carrier. Clean the thread of each bolt using a wire brush and Acetone, apply PermaBond A130 and re-install, tightening to 90 Nm.

- c) Mark the hub bolt heads with white paint.
 - d) Reassemble the suspension (see Service Notes sub-section DH.3)
 - e) Refit the roadwheels (wheel bolt torque = 105 Nm).
