SERVICE BULLETIN

Model: Elise/Exige 6-speed

Number:
2004/18

TITLE: Rectification of sticking gear lever lift tube.

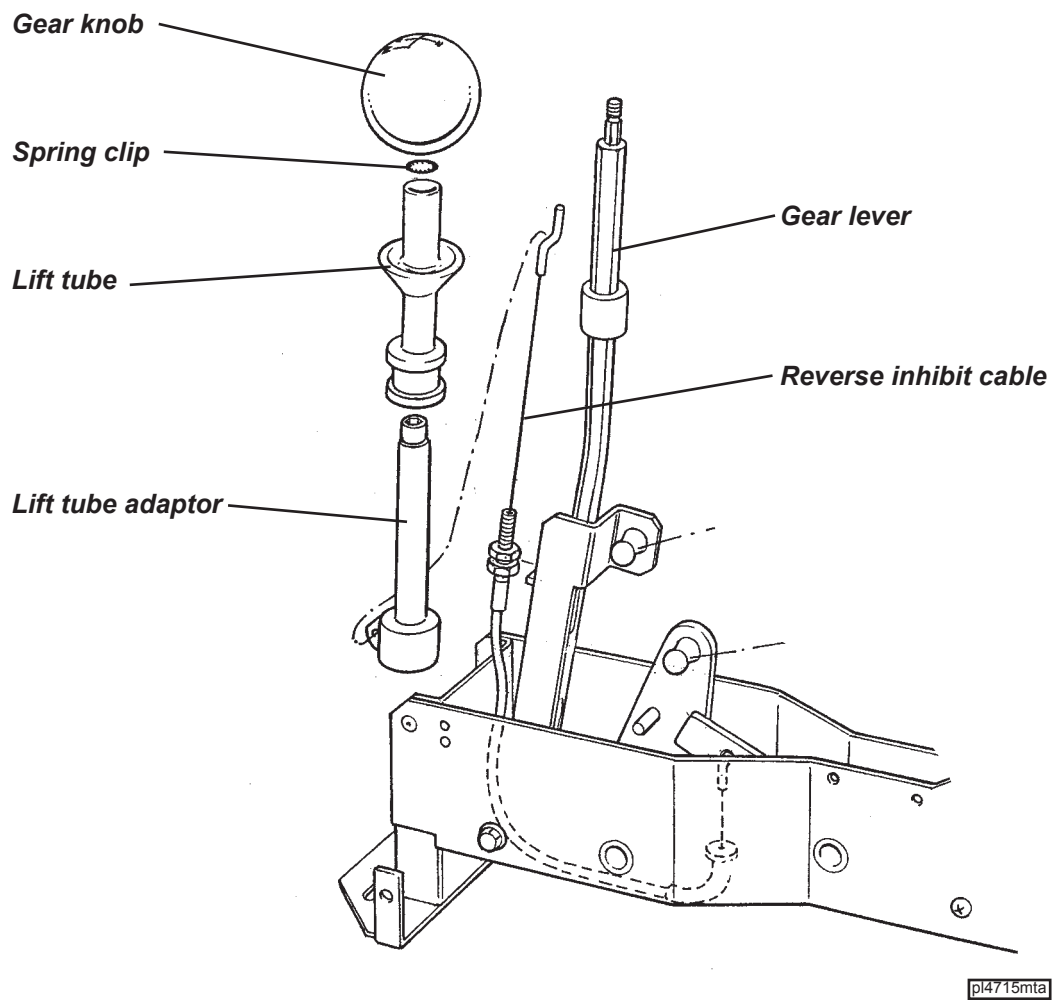
REASON: The 6-speed transmission fitted to Elise 111R/Exige 'Mk.2'/USA Elise uses a spring detent reverse gear inhibitor built into the transmission, which requires a vigorous crossgate movement of the lever to the left in order to access reverse gear. In addition to this spring detent, a positive lock out is provided on the gear lever mechanism which requires that a collar beneath the gear lever knob is raised before the lever may be moved fully to the left and over the detent. On some cars, out of tolerance components may result in the lift tube sticking in the raised position and in possible baulking on hurried 3rd to 2nd downchanges if the lever is pushed too far to the left.

3. Remove the spring steel retaining clip from the top of the plastic lift tube adaptor and slide the adaptor out of the alloy lift tube.
4. For easiest assembly, first fit the new lift tube adaptor onto the gear lever and hook in the cable. If a new lift tube adaptor is not available, the hexagonal bore of the adaptor at its tight point (the top section) must be relieved using a small file or scraper until a satisfactory fit (with spring clip fitted) is achieved.

5. Refit the shroud, taking suitable precautions to protect from scratch damage, and feed the adaptor into the alloy lift tube. Retain with the spring steel clip. Check the fit of the adaptor for free sliding on the gear lever before continuing.

7. Apply a **small** amount of thread locking compound (Permagard A130 {A912E7033V} or Loctite 243 {A918E6027V}) to the female threads inside the gear knob, and screw the knob fully onto the lever. Then progressively unscrew the knob until raising the lift collar allows selection of reverse gear, and the change pattern graphic is correctly orientated. Note: if too much adhesive is applied, contamination of the gear lever/lift tube may result in sticking of the lift tube!
