APPLICATIONS MANUAL

TIPS & HINTS

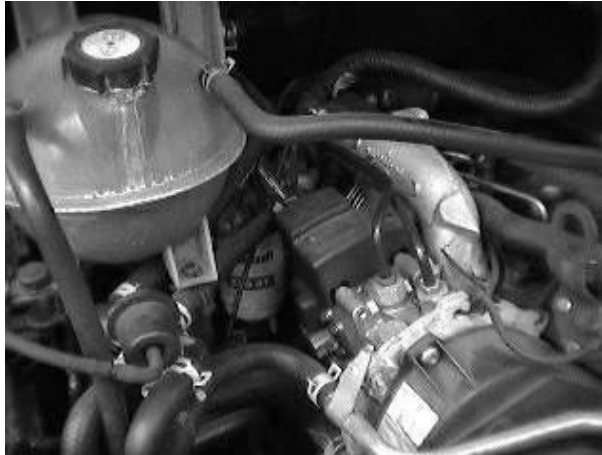
EPIC ENGINE

SYSTEM IDENTIFICATION
